The ghost in the shutter finding and correcting years of wear

Steven E. Bauman

CFHT

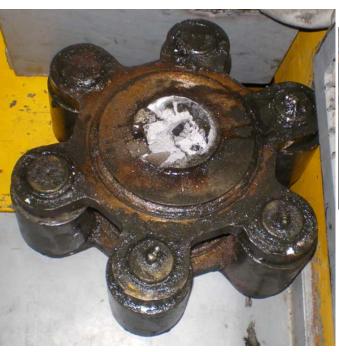
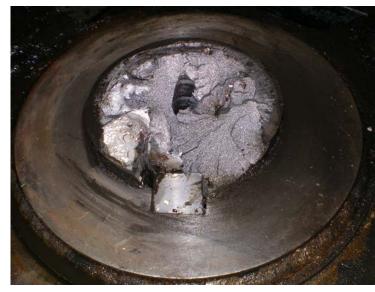
- 2nd Failure sheared gearbox output shaft metallurgical analysis
 - Overhung loads exceed shaft capacity uneven loading
 - Further study incorrectly specified output bearing

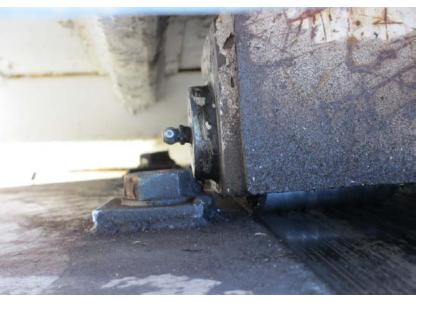
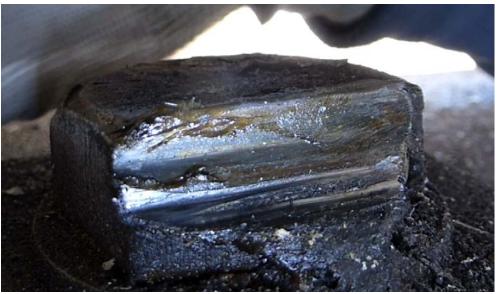
- 3rd Failure Shutter Stuck open due to less drive motors or ???
 - Further lessons Gear box(319:1) left engaged into rack

Investigation into load bangs and contact interference during motion
