Maunakea Operations and Engineering Workshop 2016

Gemini North Shutter Repairs

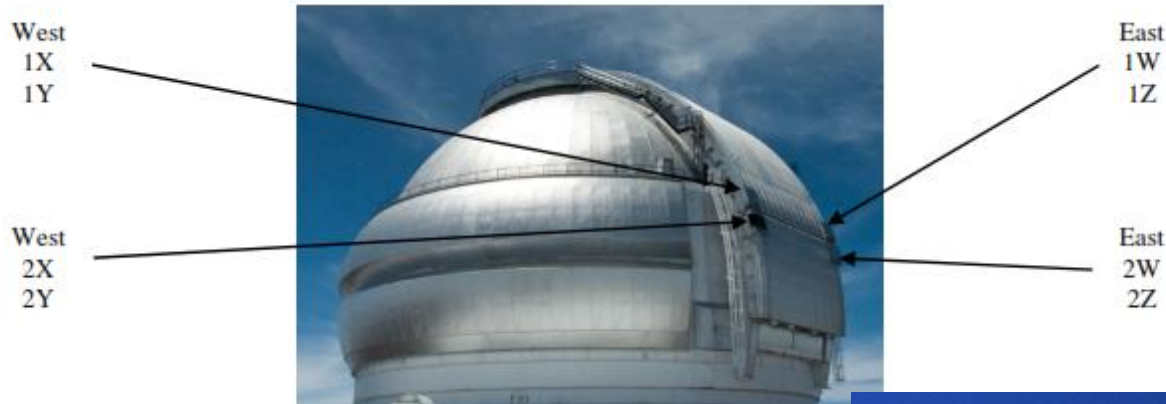
Introduction: Dome, Shutter and Chains

- 12/13: 1W/1Z failure, ~50 nights lost
- 5/14: 1X/1Y failure, ~21 nights lost
- 8/16: 2X/2Y failure, ~14 night lost
- 8/16: found 2W/2Z damaged

Bottom shutter locked out, overhaul planned for 2017

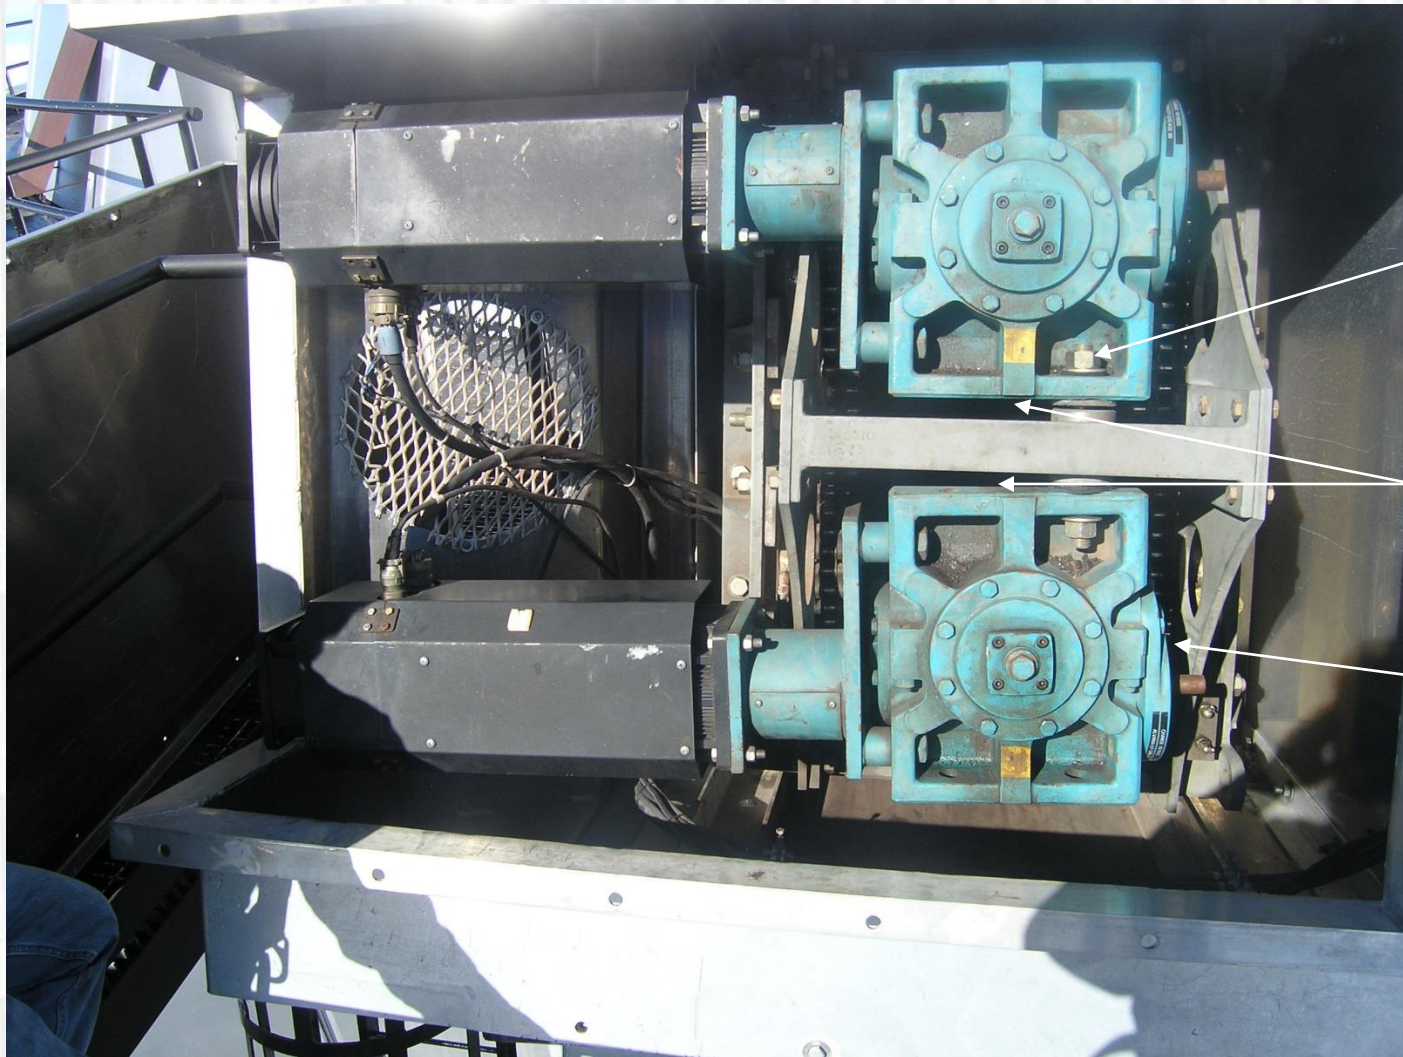
Failure Shutter Drive Boxes

Torque arm

Gap skewed for
lower gearbox

This drive shaft
bearing is broken

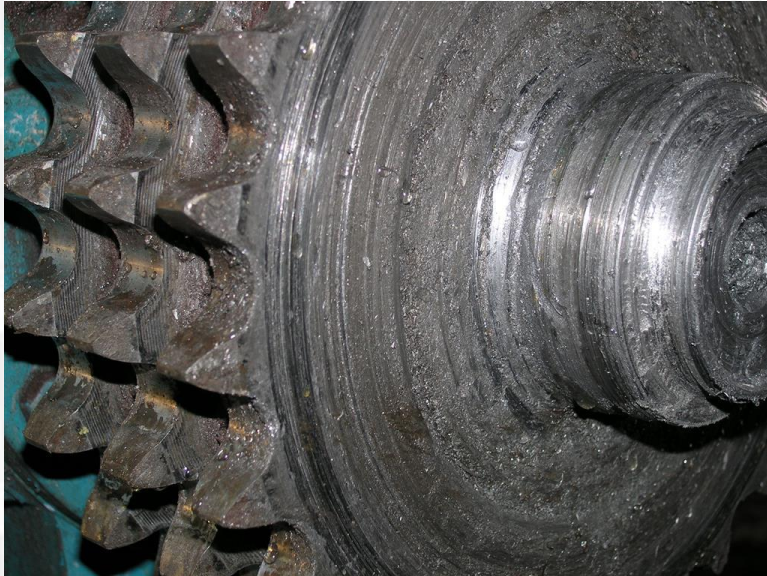
Drive shaft and sprocket

Failure Shaft and Bearing

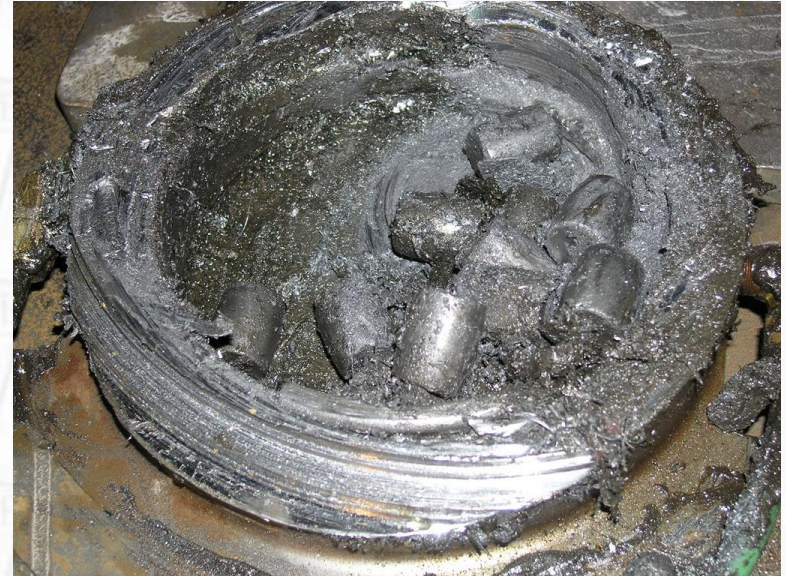
Bearing and housing

Top W/Z Failure December 2014

- Lack of lubrication and maintenance
- Bearings damaged during assembly of the drive box

- Redesign tolerances and fits for this drive box, modify parts.
- Replaced gearbox with spare
- Replace all bearings (drive shaft and idlers)
- Clean lubrication nipples and hoses
- Make special tools for mounting and assembly

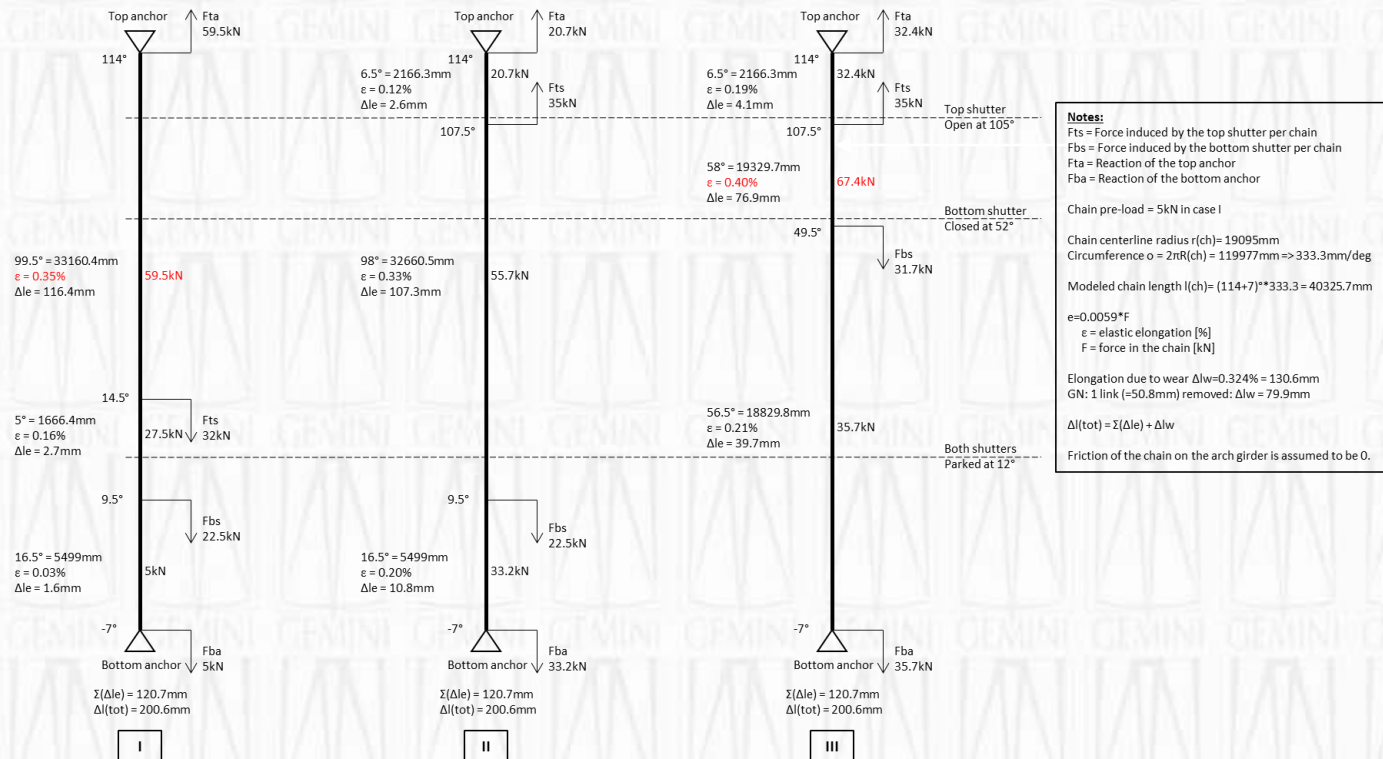
Results 1

- Chain elastic and plastic elongation caused by shutter to shutter weight
- Chain overstretching occurs when the top shutter is open and the bottom shutter is up: chain force 67.4kN vs. 54kN supplier spec.

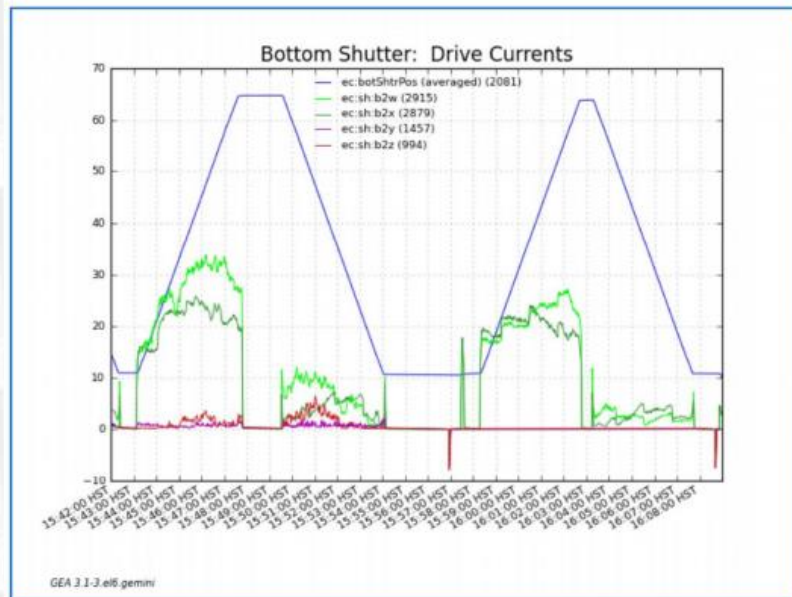
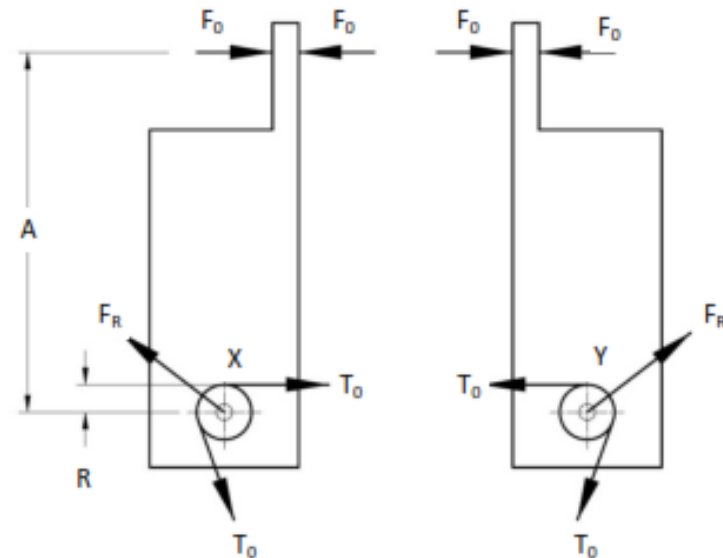
Results 2

- The torque arm design does not allow the relative movement the gearboxes need to cope with the chain elongation and position controlled motors:

- Provide spare drive boxes for both sites (done)
- Redesign torque arm (now being tested at Gemini South)
- Redesign motor drive system (being considered)
