Subaru Telescope Mirror Hatch Failure

Hirofumi Okita

Subaru Telescope

Dec. 8th, 2016

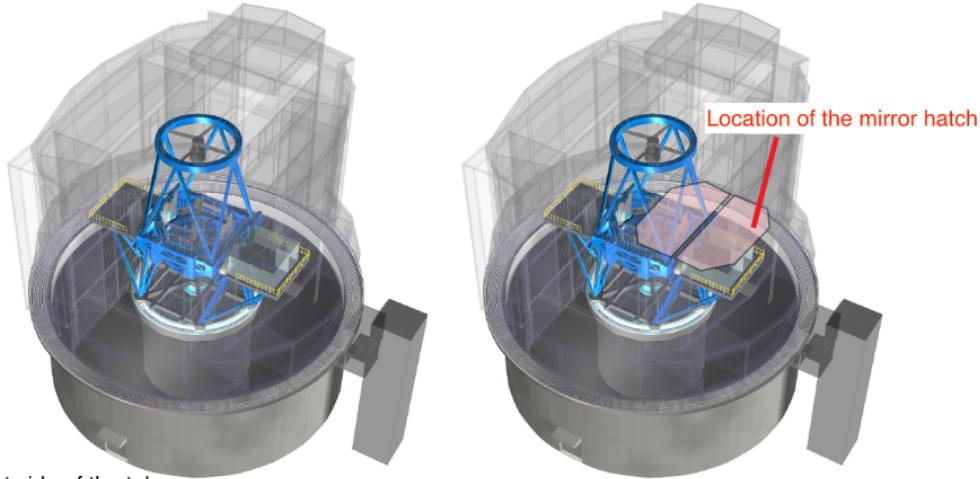
Rear side of the telescope

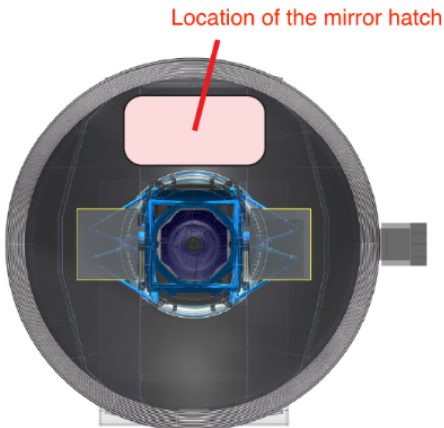
Front side of the telescope

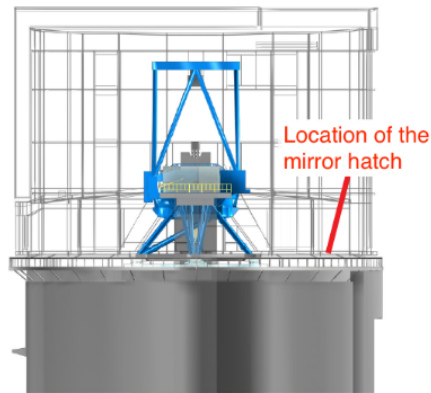
Top View

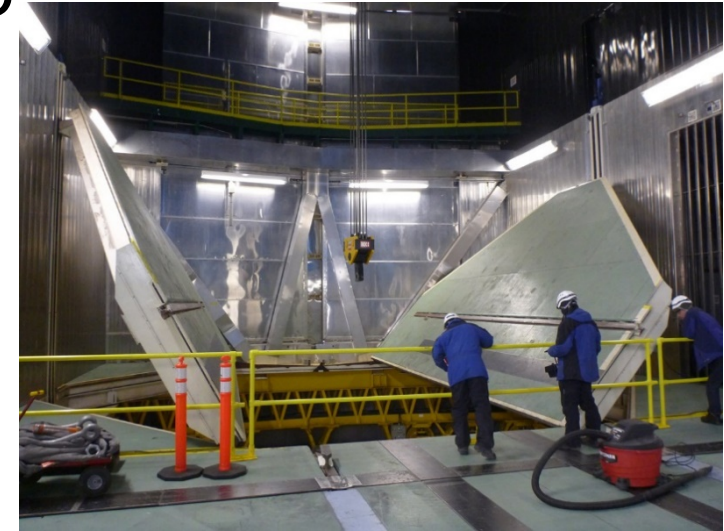
Side View

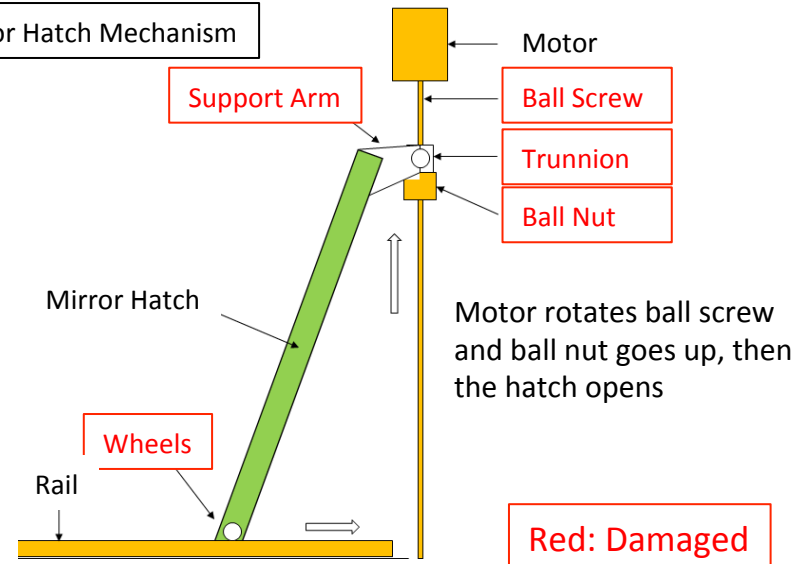
Mirror Hatch Mechanism

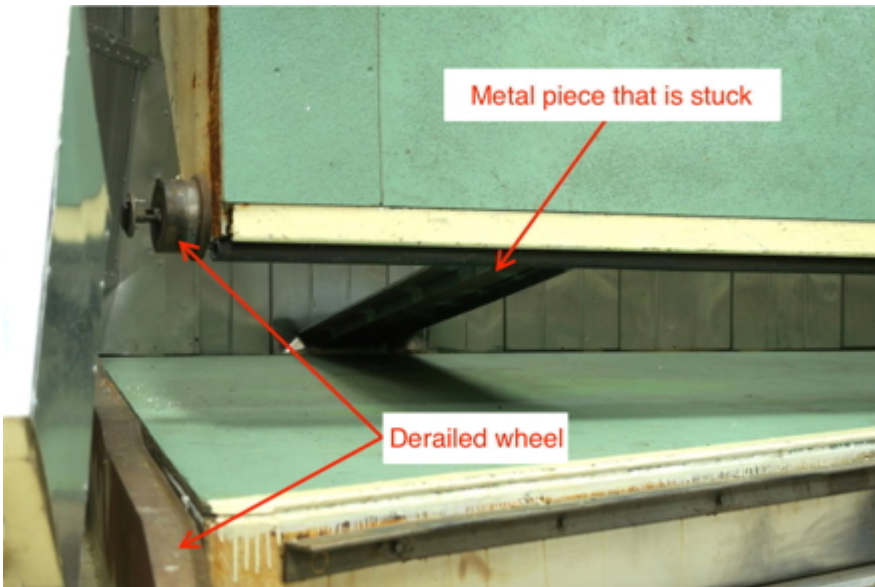
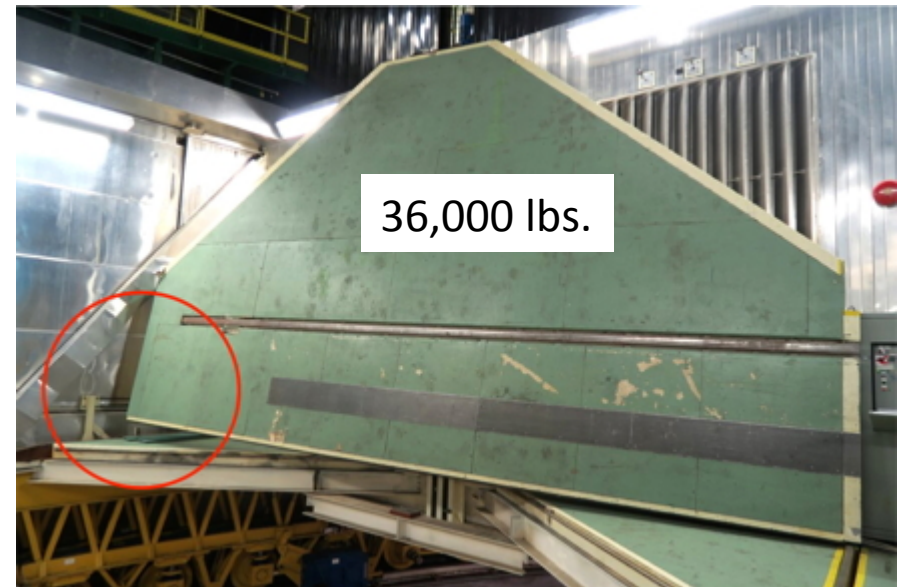
- During the scheduled maintenance work on Feb 22, a mirror hatch stopped working when a metal piece was caught while being opened.
- It was found that the wheel of the mirror hatch derailed and there are some damages to the mirror hatch.

- We hired Isemoto's the second largest crane GROVE GMK 5120B.
- The crane slung up the 35,000 lbs. hatch then put it on the original position.
- We are so sorry for **light pollution** while the recovery work. We had to ventilate diesel exhaust from the crane. We are really appreciate for your understanding and cooperation.

The hatch has not repaired yet.
We will repair it with Mitsubishi Electric CO. in the next summer.

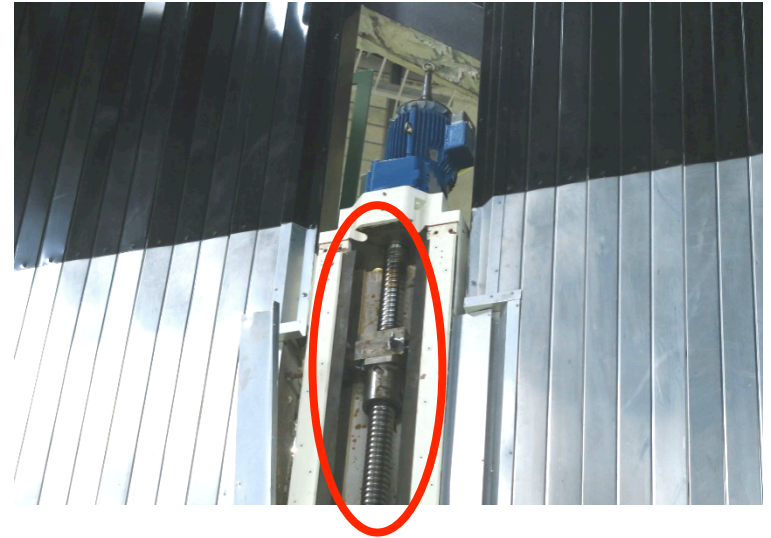
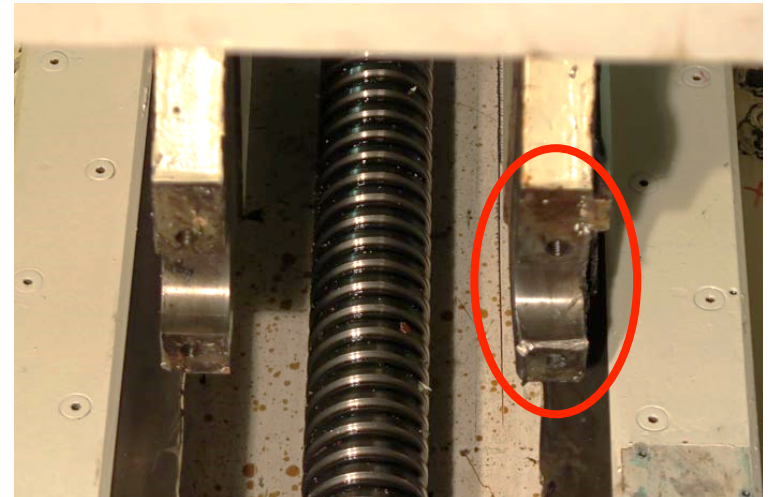
- After the mirror hatch failure, we telescope engineering division studied, asked, and discussed about how to repair it.
- We paid 8 personal resources and 6 months for that and finally decided not to repair it by ourselves.
- We have no experience to handle with such kind of large and heavy structure/mechanism. If we repaired and failed, it may kill someone. Too many risks to repair.
