Maunakea Operations and Engineering Workshop 2016

Gemini North Shutter Repairs

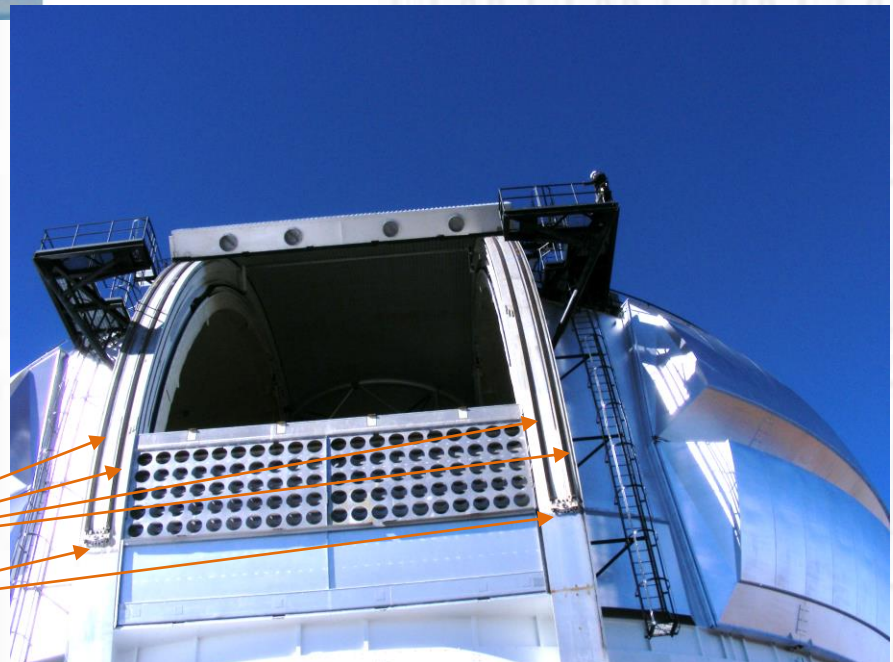
Fixed chains
Bottom anchors

- 12/13: 1W/1Z failure, ~50 nights lost
- 5/14: 1X/1Y failure, ~21 nights lost
- 8/16: 2X/2Y failure, ~14 night lost
- 8/16: found 2W/2Z damaged

Bottom shutter locked out, overhaul planned for 2017

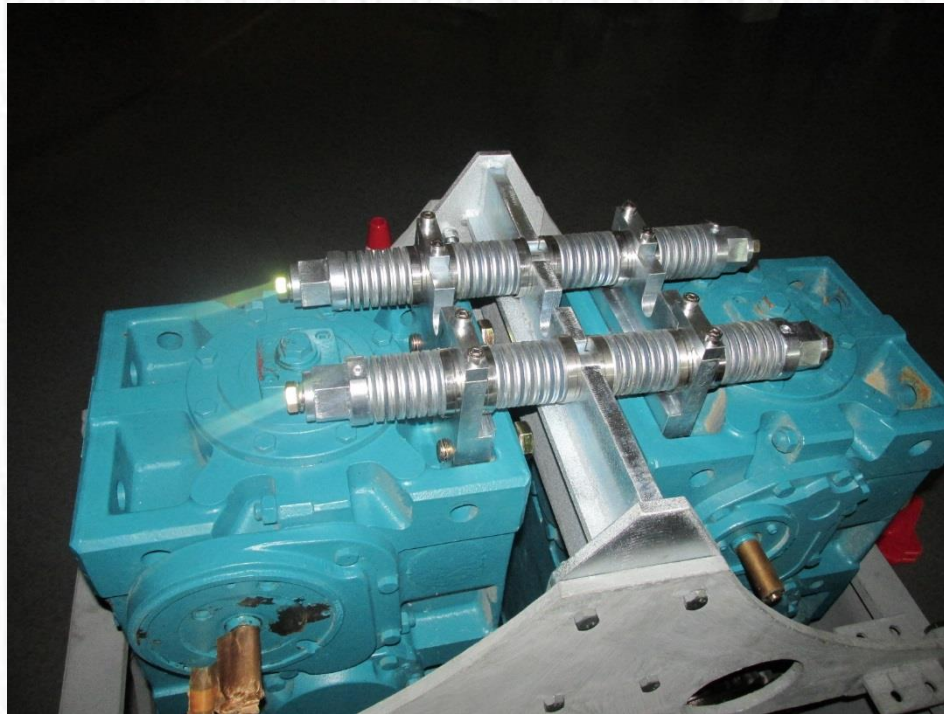
Bottom X/Y Failure August 2016

Not again !?!

- Bottom W/Z bearing also about to fail

- Replace drive box with spare (latest revision)

- Lock-out the bottom shutter in the parked position
- Make plans for 2017 to replace chains
